REZ 25-0000097 : REZONING REQUEST FROM PLANNED DEVELOPMENT (Z94-67) AND RESIDENTIAL MULTI FAMILY (RM-16) TO PD (PLANNED DEVELOPMENT) FOR RESIDENTIAL MULTIFAMILY

Client/Project  
ASHLEY EAST

ASHLEY EAST TAMPA APARTMENTS

EAST TAMPA MULTIFAMILY  
TAMPA, FLORIDA

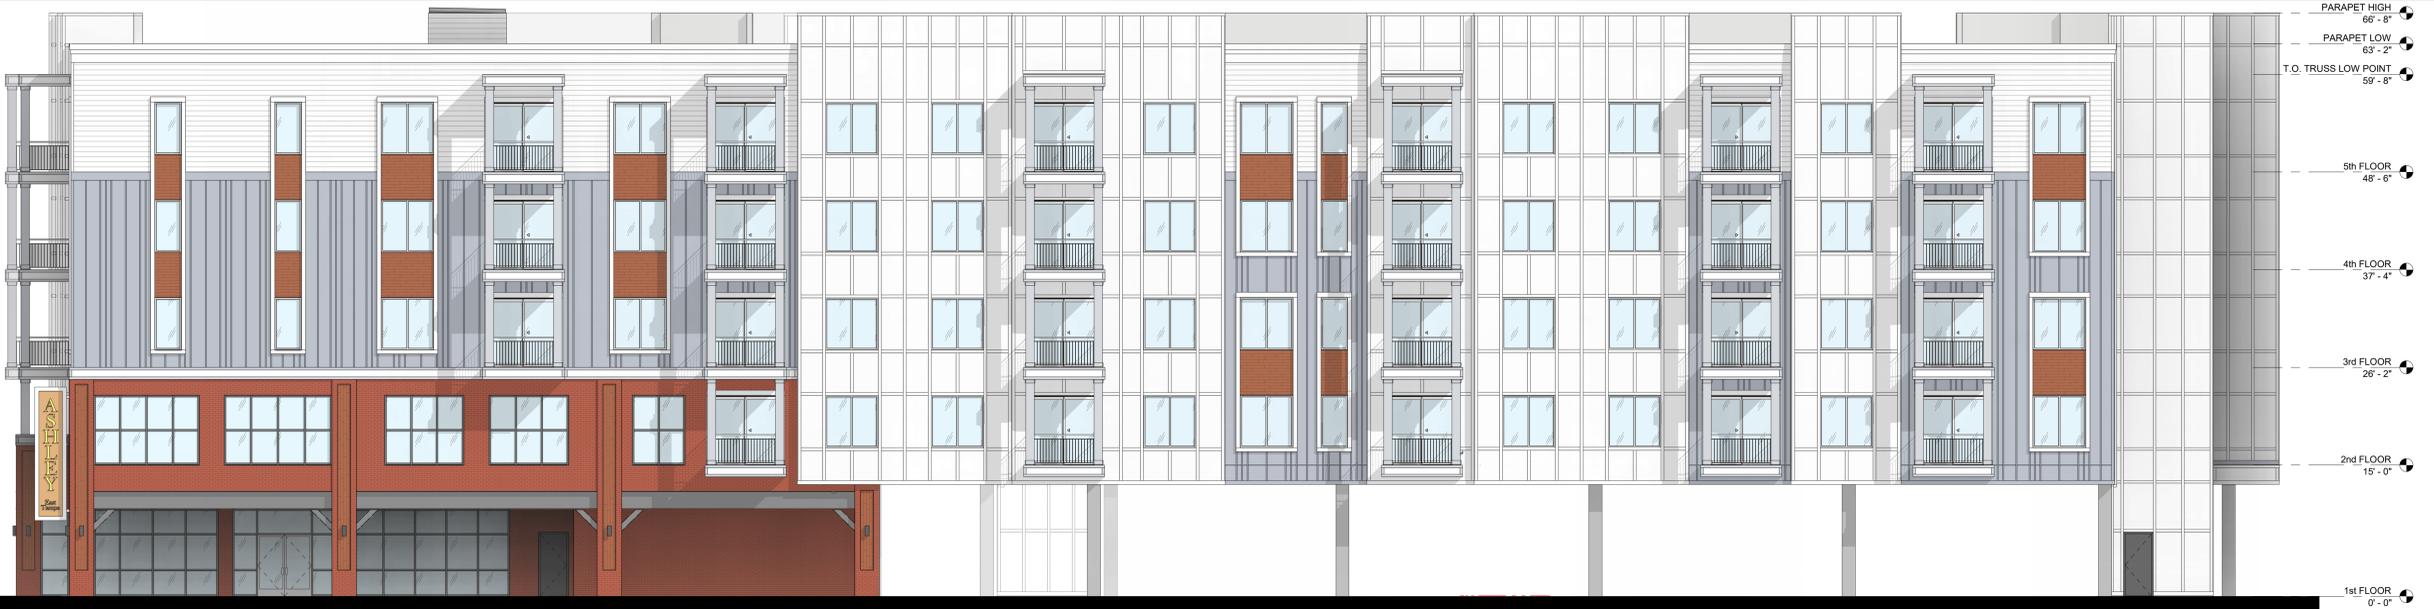
3 WEST  
1/8" = 1'-0"

- PARAPET HIGH 66'-8"
- PARAPET LOW 63'-2"
- T.O. TRUSS LOW POINT 59'-8"
- 5th FLOOR 48'-6"
- 4th FLOOR 37'-4"
- 3rd FLOOR 26'-2"
- 2nd FLOOR 15'-0"
- 1st FLOOR 0'-0"

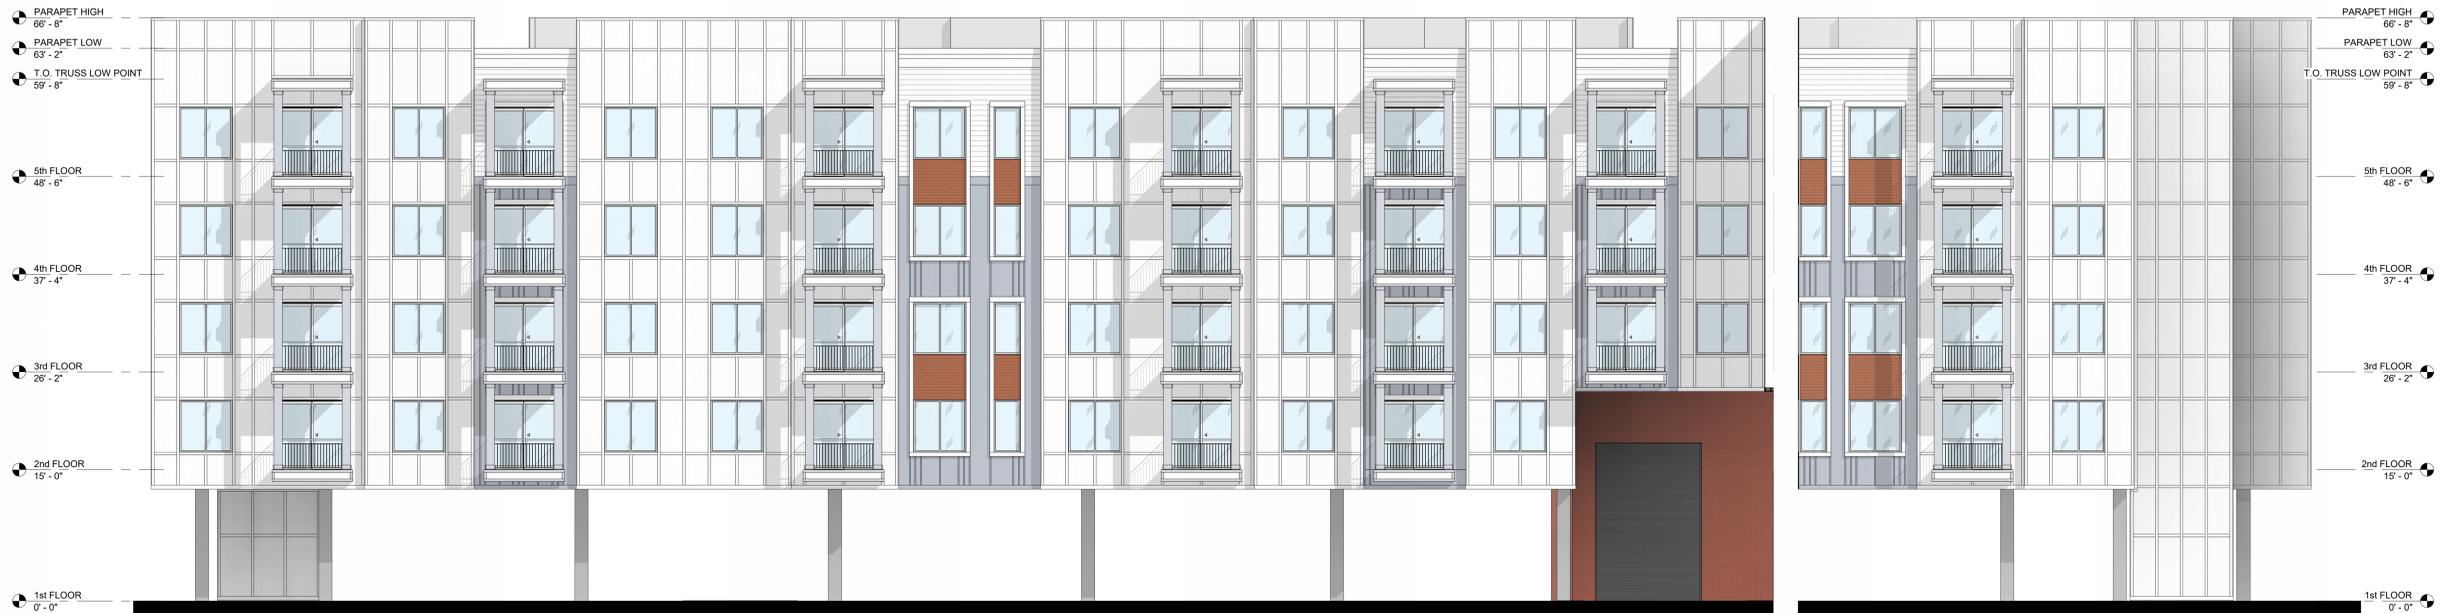
3 EAST OF WEST WING  
1/8" = 1'-0"

2 WEST OF EAST WING  
1/8" = 1'-0"

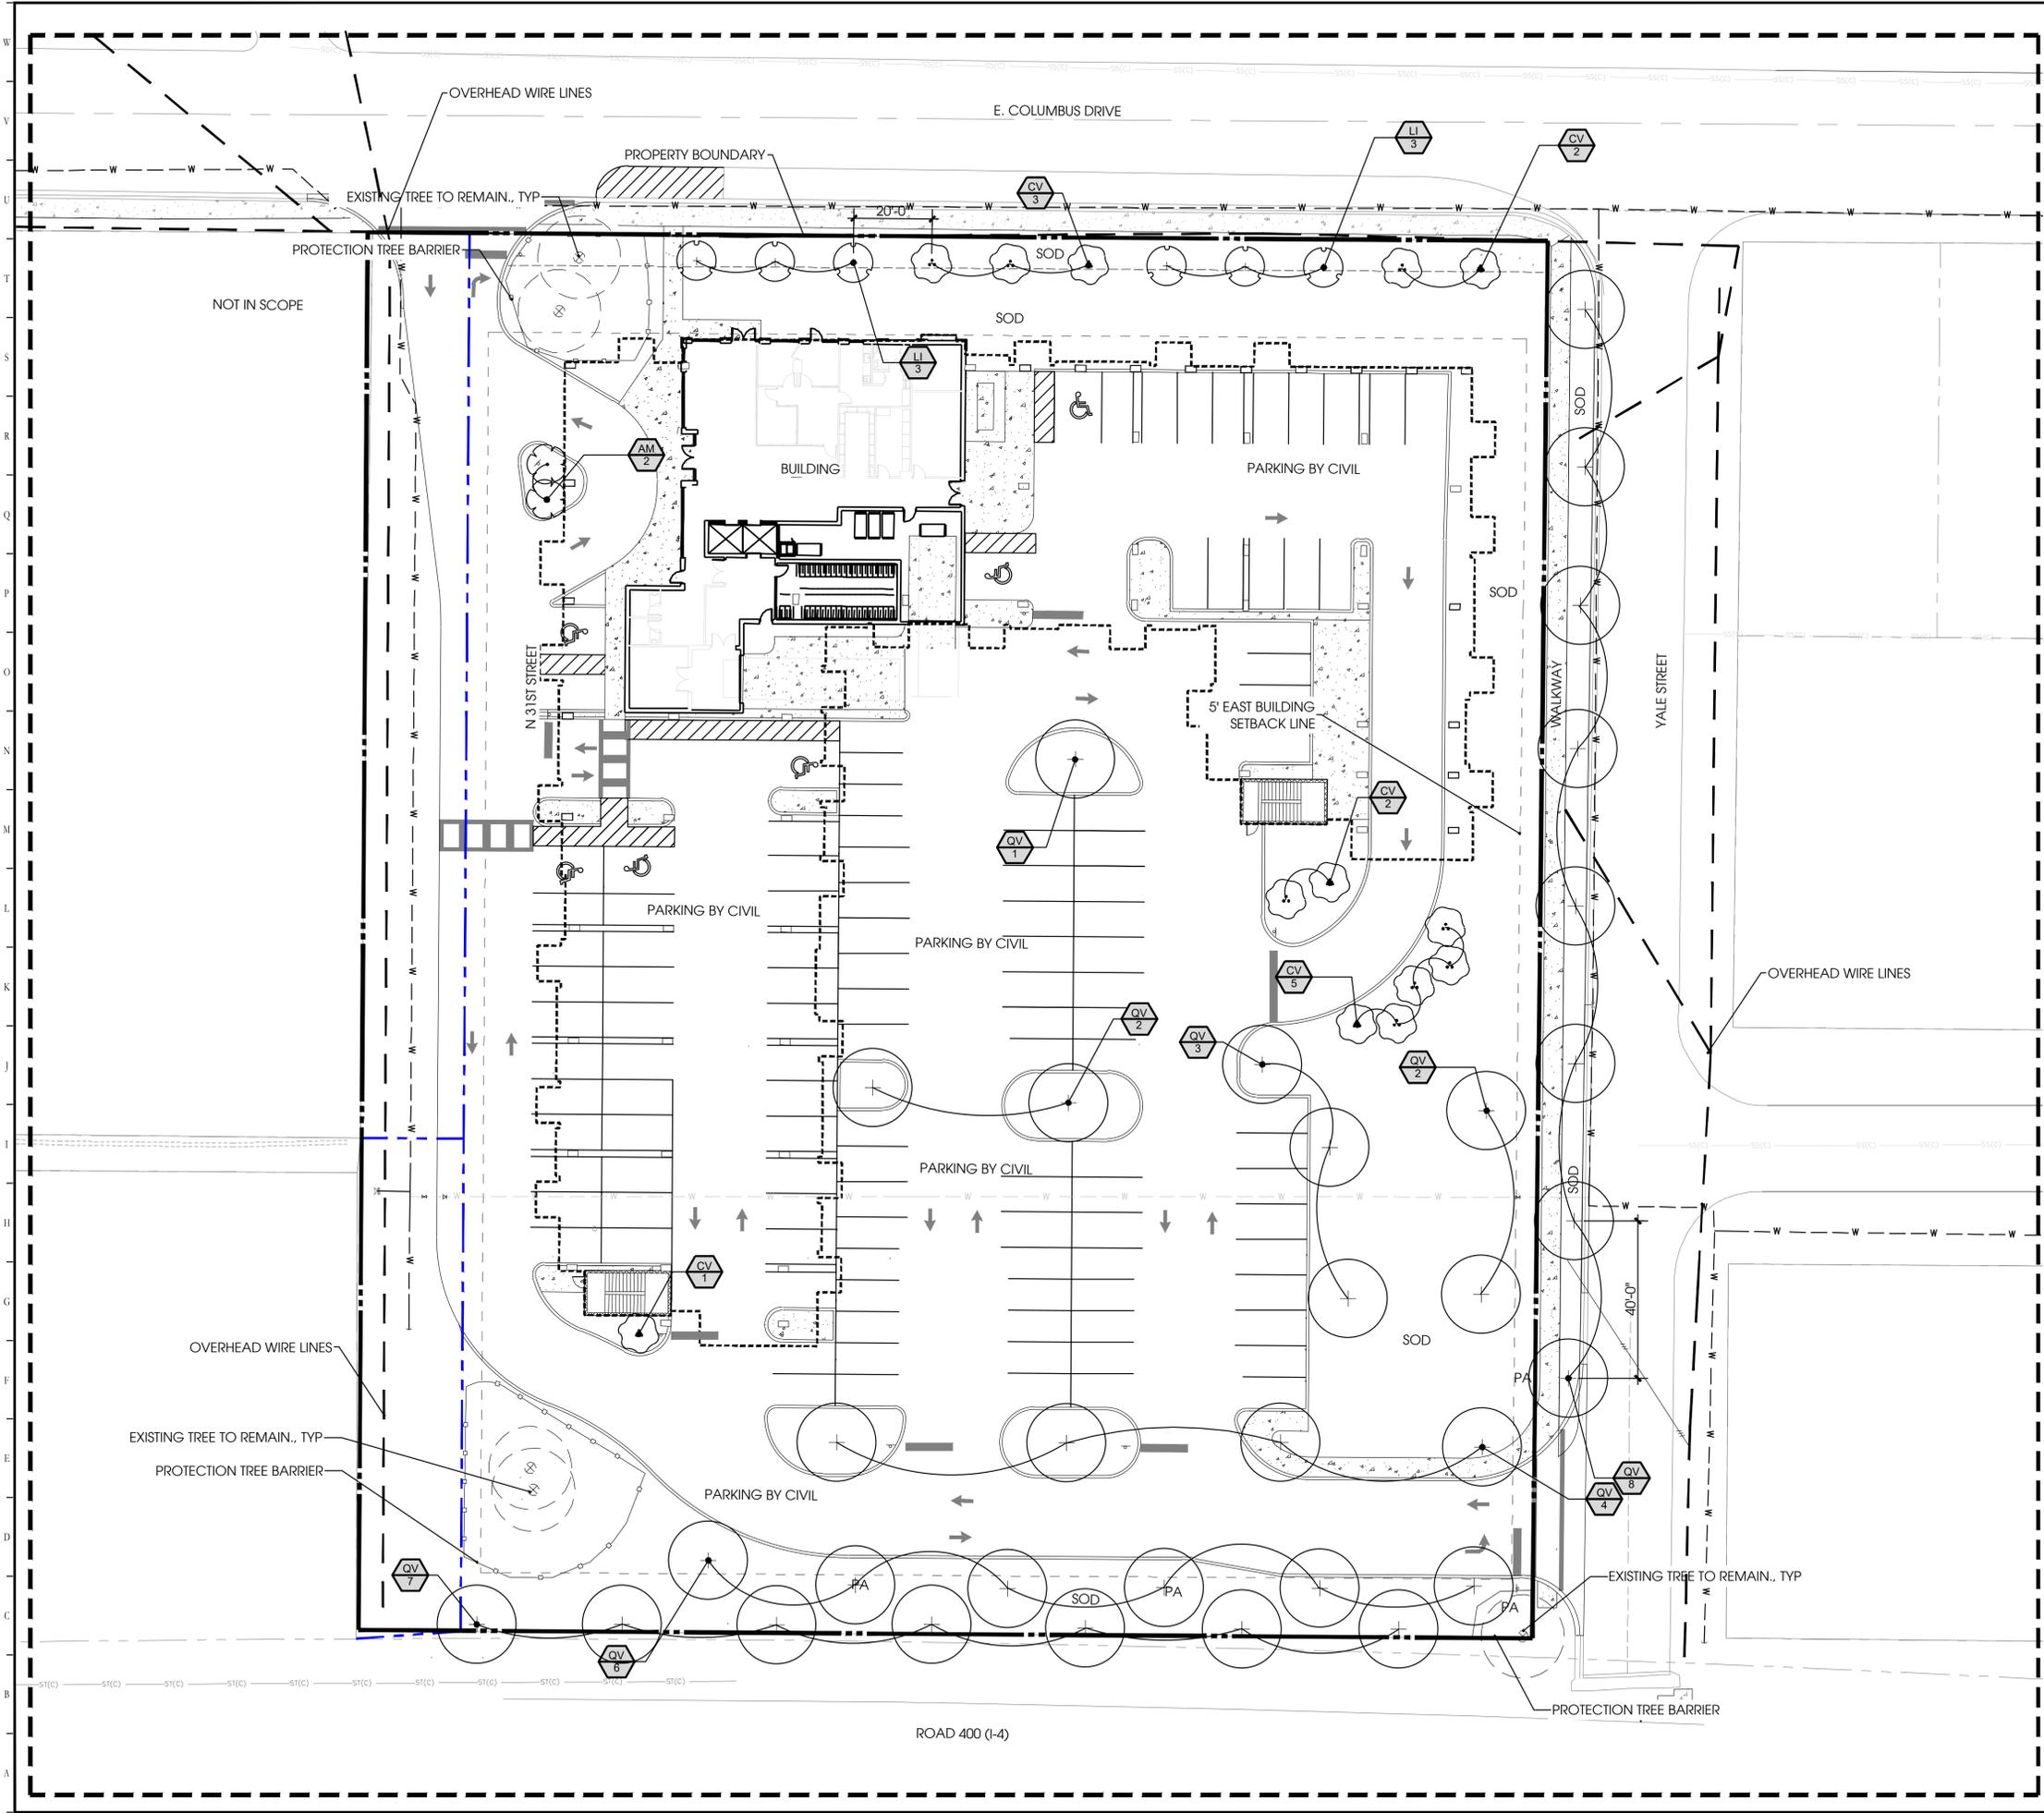
**LANDSCAPE PLAN**

CODE	COMMON NAME
<b>TREES</b>	
QV	Southern Live Oak
<b>PALMS</b>	
AM	Christmas Palm
<b>UNDERSTORY/ FLOWERING TREES</b>	
CV	Weeping Bottlebrush
LI	Crape Myrtle

NOTE: EXISTING TREES  
 ADDRESSED ON TREE  
 INVENTORY
